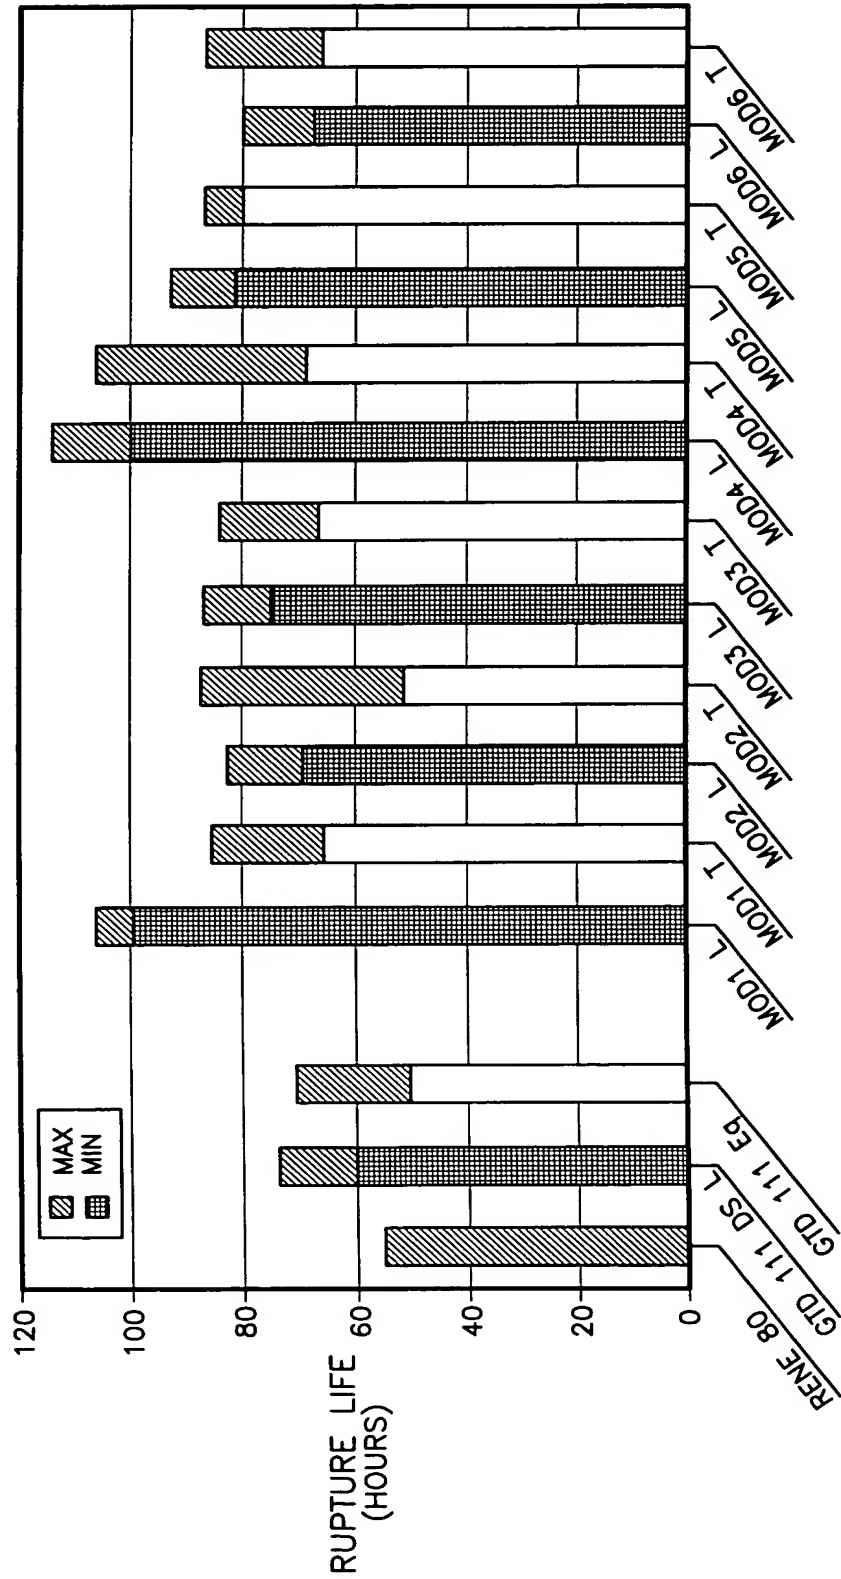
FIG.5
 LONGITUDINAL AND TRANSVERSE CREEP-RUPTURE LIFE
 OF
 CANDIDATES AT 1800°F-27ksi VS GTD 111

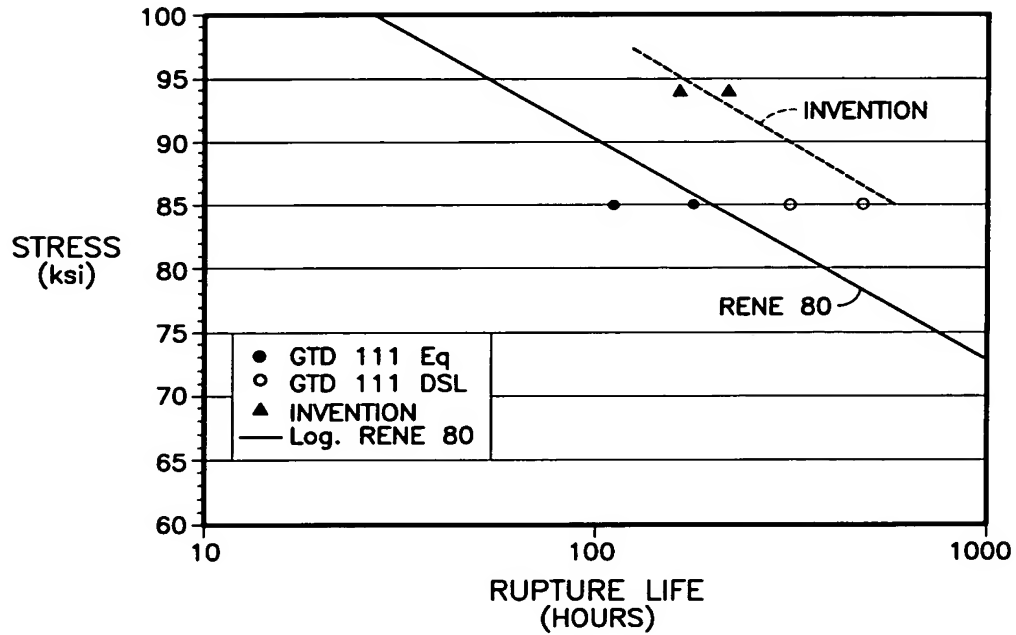
FIG.6a

SHOWS SLIGHTLY IMPROVED 1400° F
CREEP-RUPTURE LIFE VS GTD 111 DS

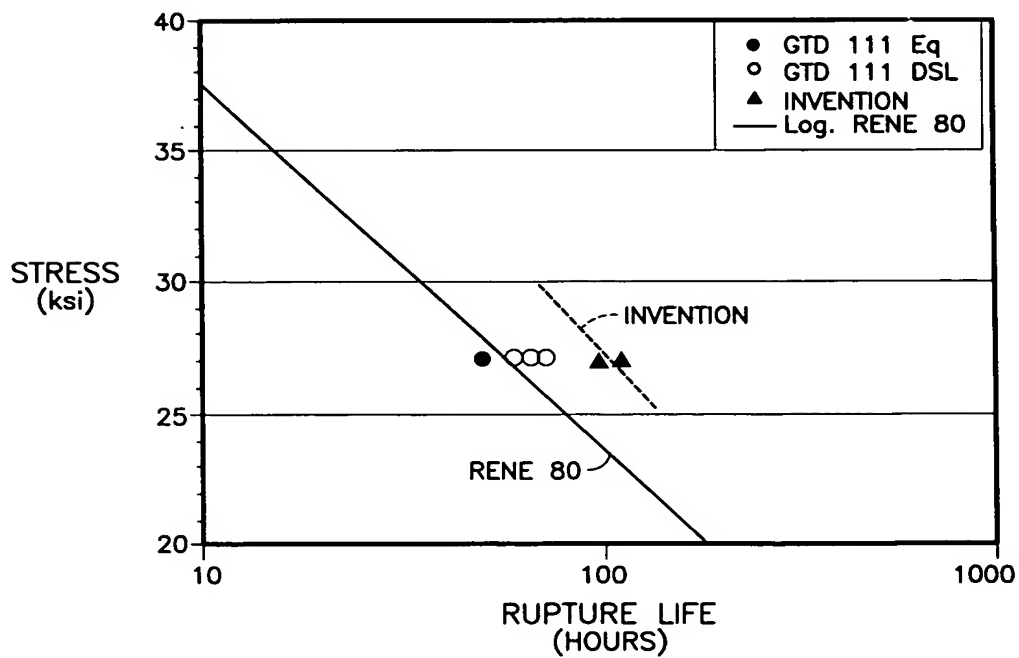
FIG.6b

SHOWS INCREASED CREEP-RUPTURE
LIFE AT 1800° F VS GTD 111 DS
